CHARTING SANTA CRUZ RIVER CONDITIONS
NORTHWEST TUCSON TO MARANA—2018 WATER YEAR

SUPPLEMENTARY REPORT FOR 2013 TO 2018 WATER YEARS

SONORAN
INSTITUTE

PIMA COUNTY

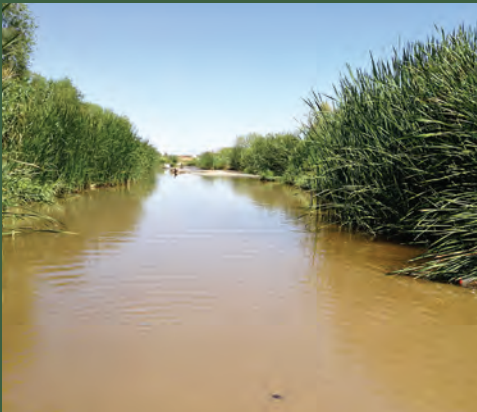
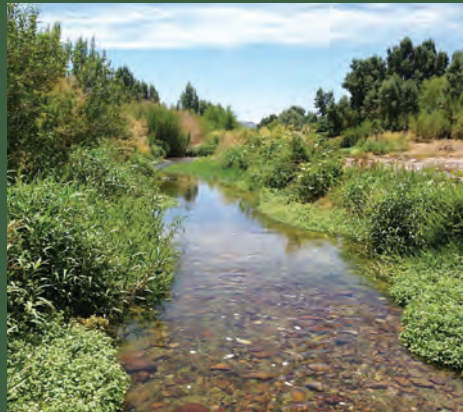
Cloudy water, before upgrade

Clear water, after upgrade

- **Water clarity much improved:** Sediments and other particles carried in the water decreased, resulting in clear river water on normal non-flooding days. Elevated sediment levels in the water can increase water temperature, thereby decreasing available dissolved oxygen.

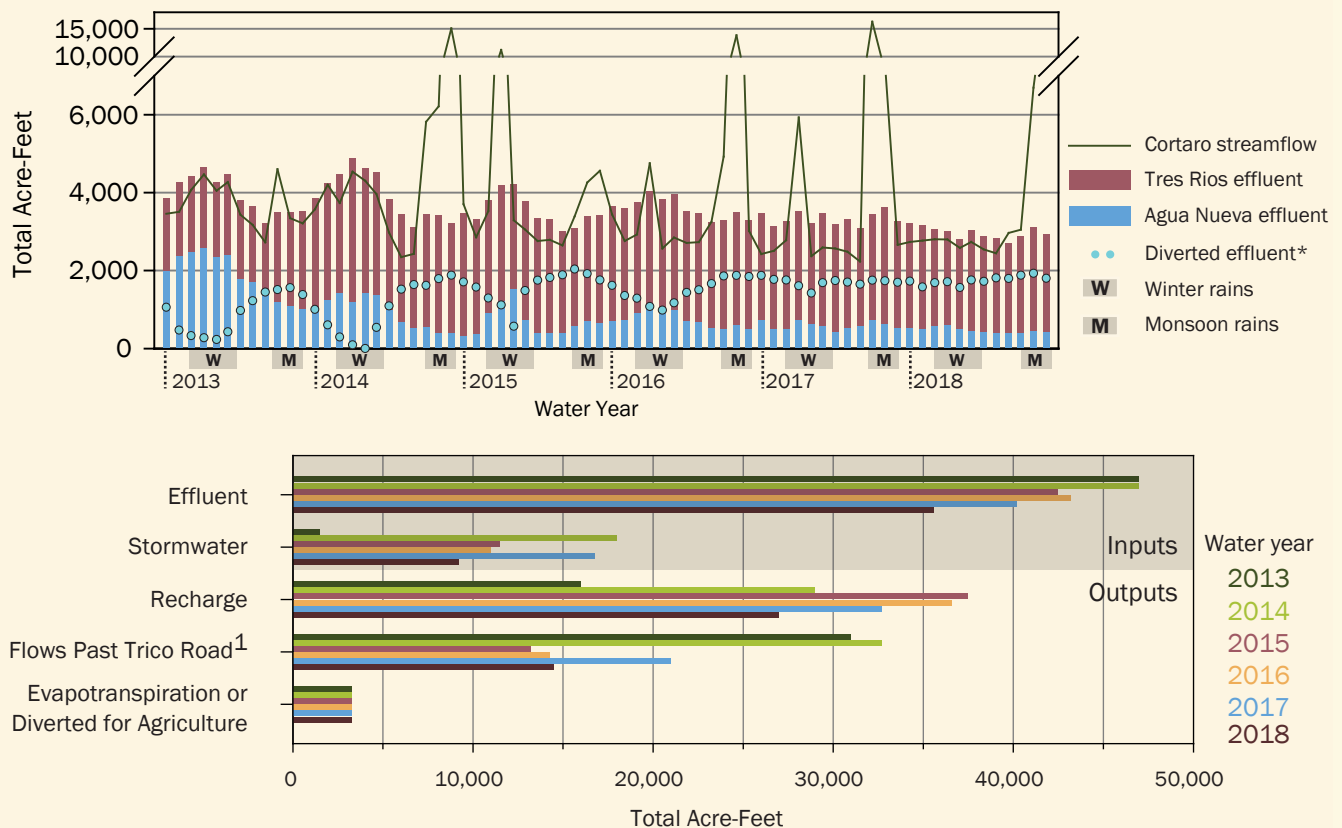
2013–2018 WATER BUDGET

A water budget estimates the water inputs and outputs. Inputs are effluent and stormwater, while outputs include water that does one of the following: flows past Trico Road (the end of the study area), evaporates or is used by wetland vegetation (a process called evapotranspiration), is diverted for agricultural use, or sinks into the riverbed to recharge local groundwater. Volumes are totaled in acre-feet (AF), the

number of acres that would be covered with water one foot deep. Total recharge volume is for effluent only and does not include stormwater. Totals for evapotranspiration and diversions are not directly measured. They are estimates and viewed as fairly constant from year to year in the calculations for the managed recharge projects located along the Lower Santa Cruz River.

* Includes effluent that doesn't go to the river; either it is diverted to the reclaimed system for irrigation or to recharge basins located outside the river channel.

¹ Excluding days with stormwater, the volume of only effluent flowing past Trico Road is: 2013 = 26,800 AF; 2014 = 13,400 AF; 2015 = 2,100 AF; 2016 = 3,800 AF; 2017 = 3,700 AF; 2018 = 6,000 AF

Effluent provides most of the flow in the river. Effluent releases from Agua Nueva have decreased for two reasons. First, the facility upgrade completed in December of 2013 resulted in some wastewater being redirected to Tres Rios and released further downstream. Second, more effluent was diverted, before release into the river, into nearby basins to recharge local aquifers. Diverted effluent reached a steady volume starting in 2017 water year. Overall, effluent inputs were reduced by an average of 13% since 2013, with 2018 representing the lowest volume released. Total inputs increased with higher volumes of stormwater. Even with greater inputs, recharge increased significantly, likely from higher infiltration rates after improved water quality. Increased infiltration has also reduced the amount of water that flows past Trico Road. Exact volumes of water diverted for agriculture and used by wetland vegetation are not known and treated as constants in recharge calculations.
