# a living river

SANTA CRUZ RIVER 2024 DOWNTOWN TUCSON TO MARANA

SUPPLEMENTARY REPORT FOR 2013 TO 2023 WATER YEARS

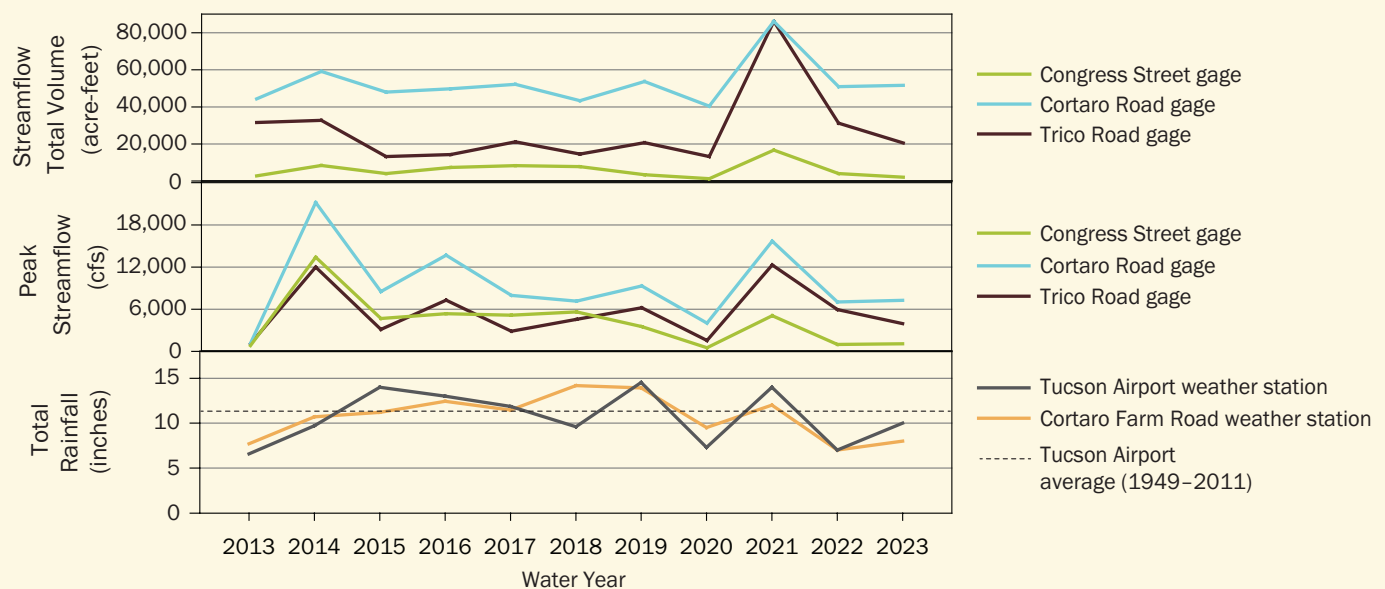
### 2013–2023 STREAMFLOW

Streamflow is measured in cubic feet per second (cfs) and represents the volume of water flowing past a fixed point in one second. Streamflow is measured with gages at Congress Street (Heritage Project) and at Cortaro and Trico Roads (northwest Tucson to Marana reach). The Cortaro Road gage also captures flows from two major tributaries that enter just upstream. Total volume sums all of the water passing a gage, allowing comparisons of streamflow between water years. Peak streamflow is the largest volume of water flowing past a gage, allowing the tracking of flood events.

At Congress Street and Cortaro Road, total streamflow has remained steady over the years. Flows at Trico Road decreased after the facility upgrades were completed in December of 2013, with fewer days when there is flow (see Flow Extent). All gages recorded the highest total flows in 2021 when monsoon rainfall was high. Peak streamflows were highest in 2014, with the exception of Trico Road whose largest peak streamflow is in 2021.

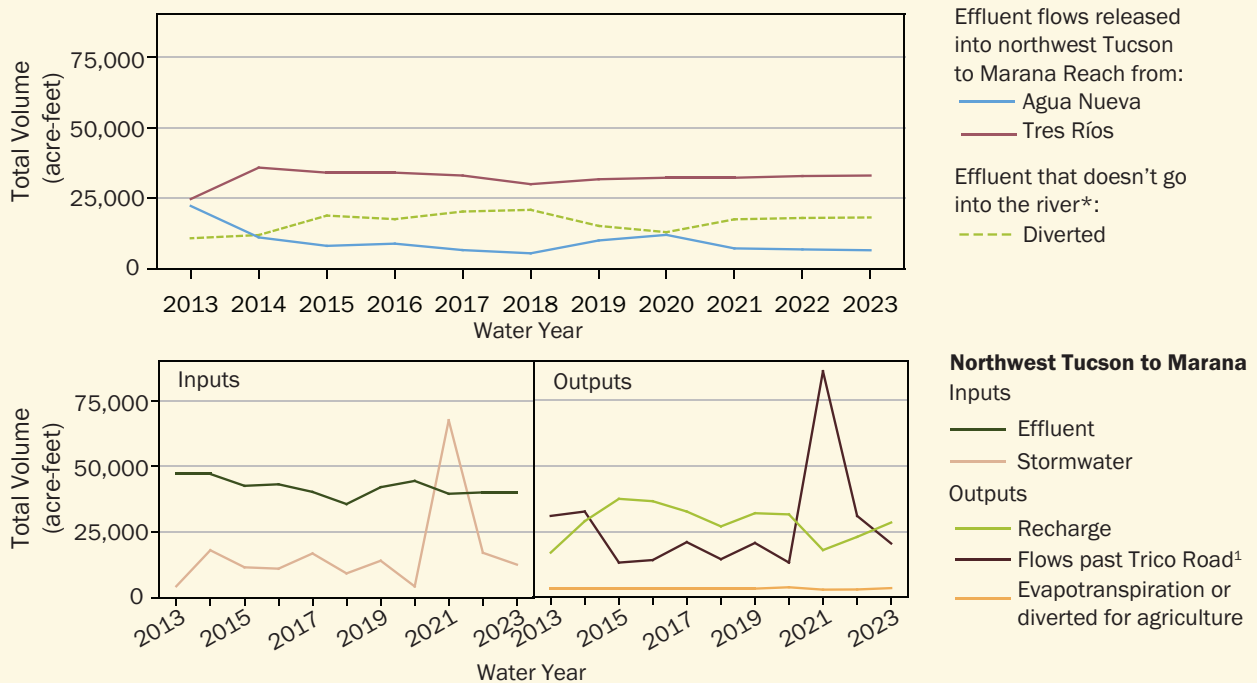
A water budget quantifies the water inputs and outputs. Inputs to the Santa Cruz River are effluent and stormwater. Effluent flows come from regional wastewater reclamation facilities, Agua Nueva and Tres Ríos. Since 2022, the Tucson Airport Remediation Project contributed additional effluent flows to the river that have influenced conditions in the Heritage Project reach. Outputs include water that does one of the following: flows past the end of the study area (Trico Road for northwest Tucson to Marana reach and Congress Street for the Heritage Project reach), evaporates or is used by riparian vegetation (evapotranspiration), is diverted for off-channel recharge or agricultural use, or percolates through the riverbed to recharge the local aquifer. Volumes are totaled in acre-feet (AF), the number of acres that would be

covered with water one foot deep. In the northwest Tucson to Marana reach, there are two managed recharge projects. Recharge is calculated by summing the flow past the Trico Road gage, evapotranspiration, and off-channel diversions, and then subtracting the volume discharged into the river. The difference is the volume recharged. In the Heritage Project reach downtown, Tucson Water calculates recharge similarly by summing the flow past the Congress Street gage and evapotranspiration, and then subtracting this from the total water delivered to the river. For accounting purposes, recharge from stormwater is not quantified. When stormwater is known to be present in the river channel, recharge is assumed to be zero, and managed recharge projects do not receive any credits.

\* Includes effluent that is diverted from Agua Nueva either to the reclaimed system for irrigation or to recharge basins located outside the river channel.

<sup>1</sup> Excluding days with stormwater, the volume of effluent flowing past Trico Road is: 2013 = 26,800 AF; 2014 = 13,400 AF; 2015 = 2,100 AF; 2016 = 3,800 AF; 2017 = 3,700 AF; 2018 = 6,000 AF; 2019 = 6,000 AF; 2020 = 10,800 AF; 2021 = 16,800 AF; 2022 = 13,200 AF; 2023 = 9,300 AF

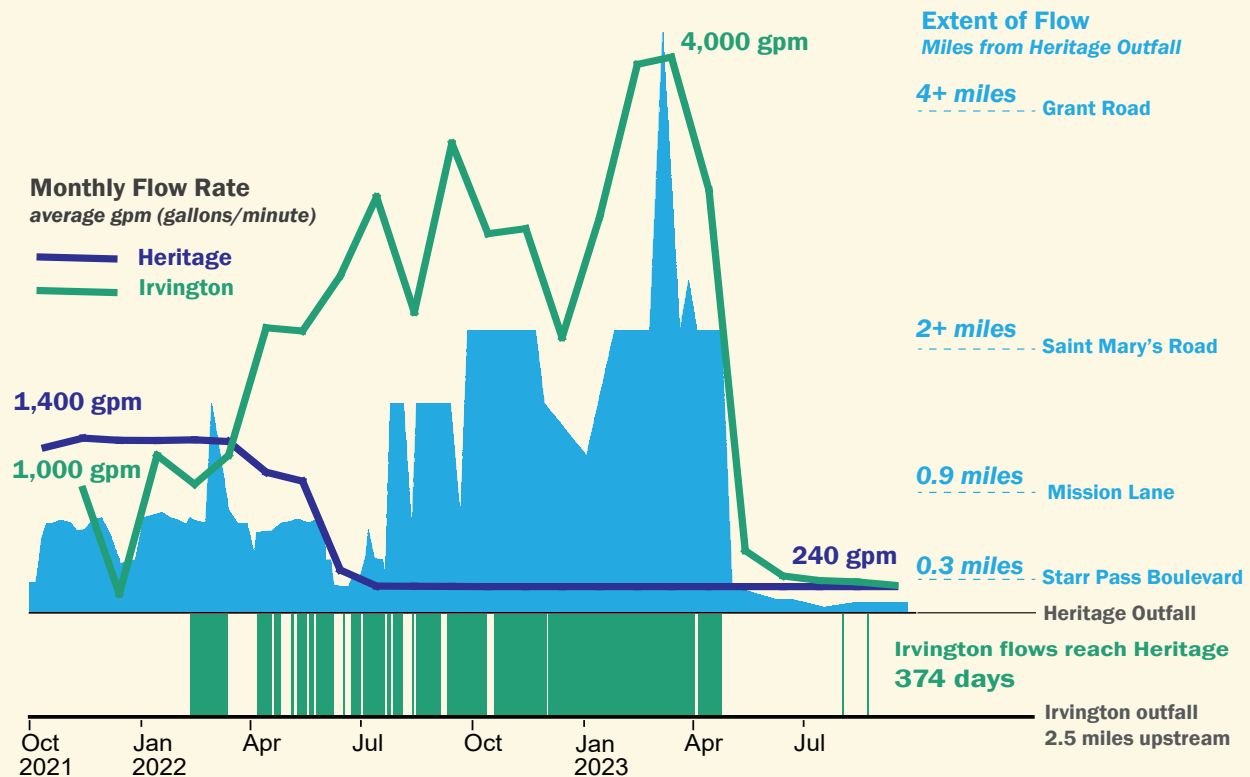
## 2019–2023 HERITAGE PROJECT REACH

Tucson Water started adding effluent to the Heritage Project reach in June 2019. For most of the year, effluent discharge is the only source of water. This was especially true in 2020 when stormwater flows were minimal. However, stormwater contributed significantly to flows in 2021 with the strong monsoon activity. Starting in 2022, water from the Tucson Airport Remediation Project began influencing conditions (see next page). With the extra water in the river, Tucson Water did not release effluent into the Heritage Project reach in 2023. Instead, the water released from the Heritage Outfall was groundwater sourced from a nearby well. This steady water sustained the small wetland habitat near the outfall. For the Heritage Project water budget, the recharge and evapotranspiration reported here are the values officially calculated as part of the managed recharge project. Recharge was zero in 2023 because only effluent releases are used in recharge calculations. As such, evapotranspiration is also zero.

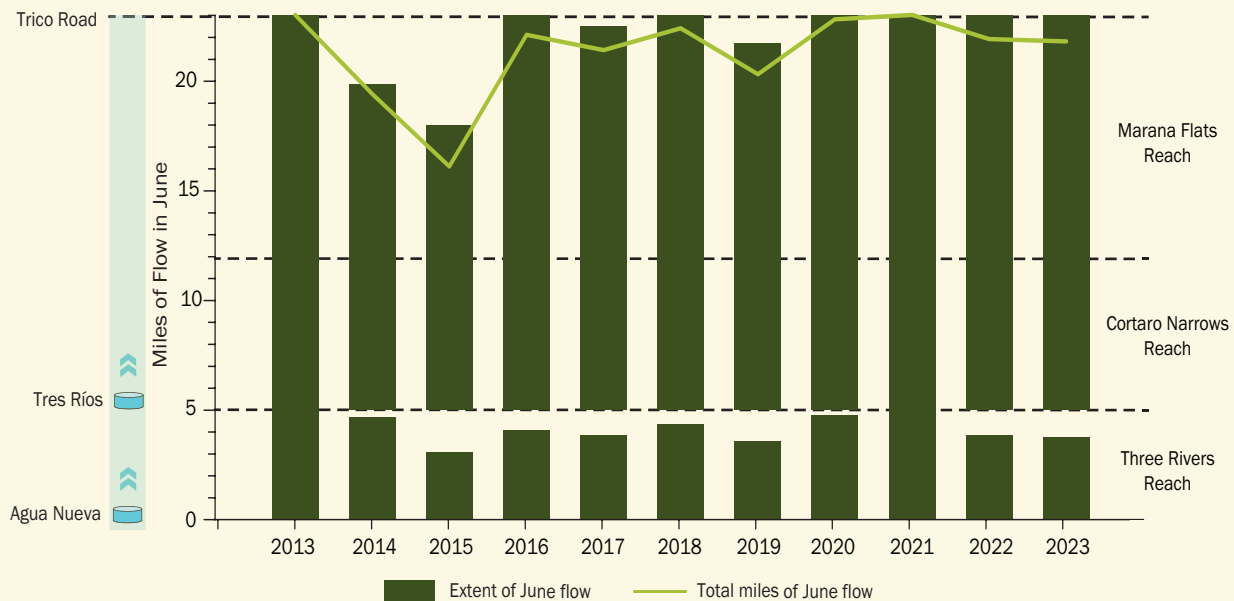
Measuring the **miles of flow in June** from the outfalls to the end of each stretch of river prior to the monsoon season determines the minimum extent of flow in each reach during the driest time of year. This is typically measured on one morning in mid-June.

## 2013–2023 NORTHWEST TUCSON TO MARANA REACH RESULTS

Flow extent decreased and was more variable after the December 2013 upgrades. In June 2013, the river flowed uninterrupted to the end of the 23-mile study area and continued another 5 miles further into Pinal County. Uninterrupted river flow occurred again in June 2021, with the river reaching past the 23-mile study area. In other years, dry river stretches of varying lengths have formed between Agua Nueva and Tres Ríos reclamation facilities, and upstream of Trico Road.

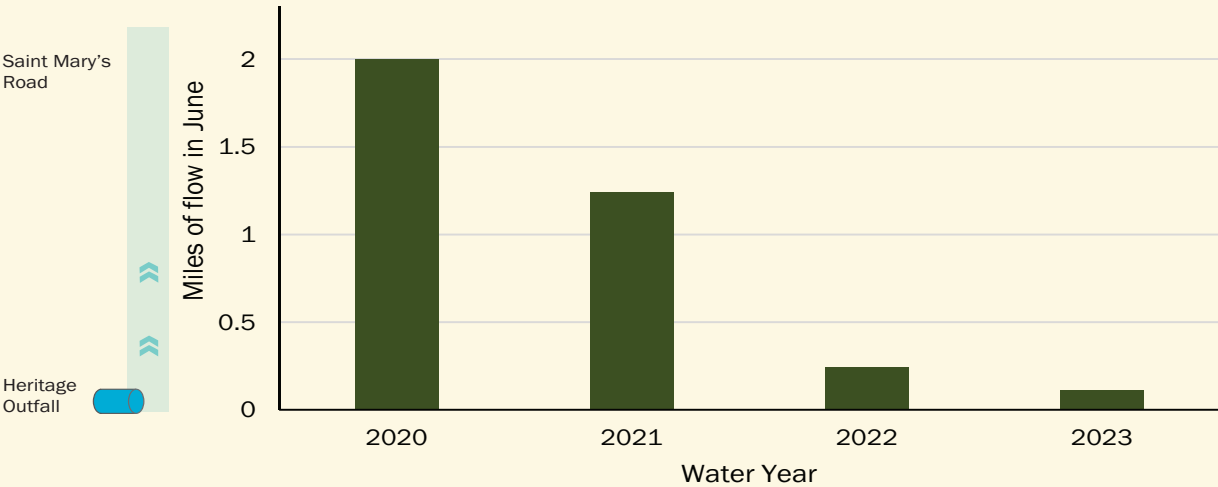
**2019–2023 HERITAGE PROJECT REACH RESULTS**

In June 2023, the river flowed approximately 0.11 miles from the Heritage Project outfall. This is the shortest extent seen since 2020 when this annual monitoring began. There are many reasons flow extent varies, as has been discussed in the water context section. Inputs in this highly managed reach are closely monitored and adjusted. The rate of recharge also plays a role, and the significant monsoon activity of 2021 scoured the river bed, increasing its recharge capability and reducing the flow extent post flood.

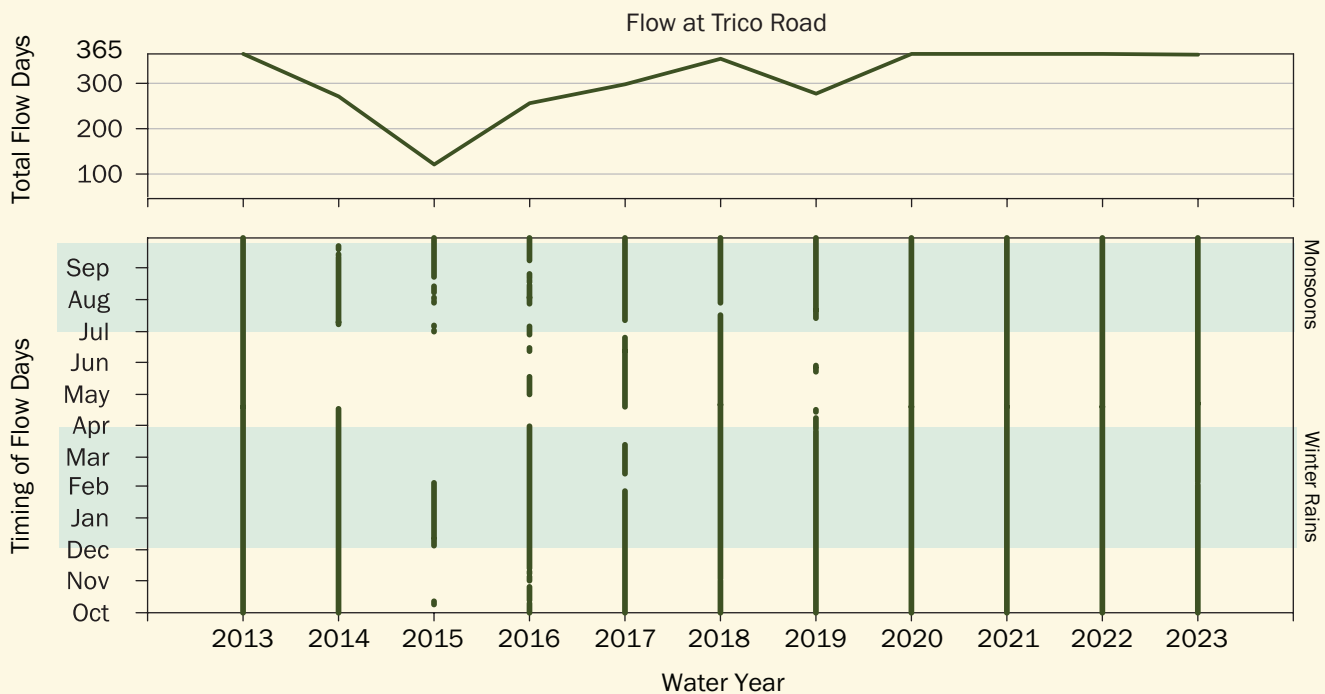
The Heritage Project is still so new, and flows are highly variable and dependent on the volume of water released. However, a stream gage managed by U.S. Geological Survey has been recording streamflow at Congress Street from long before the Heritage Project started, allowing us to monitor “flow days” at Congress Street since 2013 when this study began.

### 2013–2023 NORTHWEST TUCSON TO MARANA REACH RESULTS

In 2023, only 363 flow days were recorded at Trico Road because this location was dry for two days in February for the first time since 2019.

The daily flow at Trico Road was more variable since the treatment upgrades in 2013. Between 2014 and 2019, there were fewer days of flow during the dry hot summer months. The lowest number of flow days occurred in 2015 and 2016 and has been increasing since. In addition to increased recharge and human management of river flow, natural flooding has likely influenced conditions at Trico Road. In September 2014, floodwaters moved the location of the low-flow channel and breached a berm along the El Rio Preserve, a former borrow pit near the start of Marana Flats. This allowed water to flow into the pit and form the wetlands at El Rio Preserve. In addition, the 2014 peak flood was the largest since the 2013 upgrade and may have further increased the infiltration rate. This combined with diversion of flow into the wetlands may have decreased the number

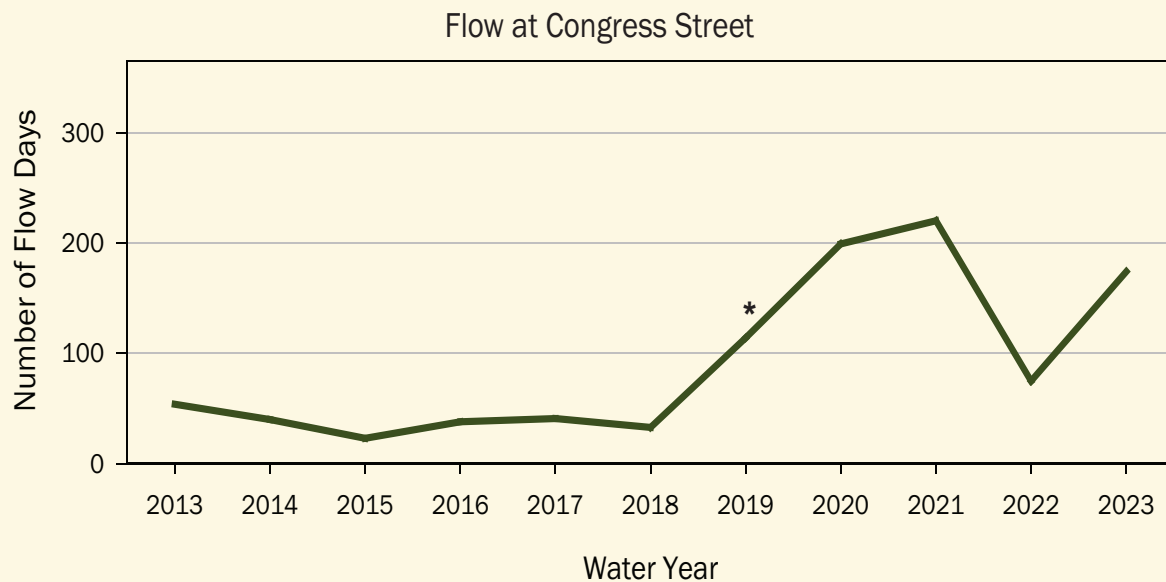
\*Santa Cruz River Heritage Project flows began June 24, 2019

## 2019–2023 HERITAGE PROJECT REACH RESULTS

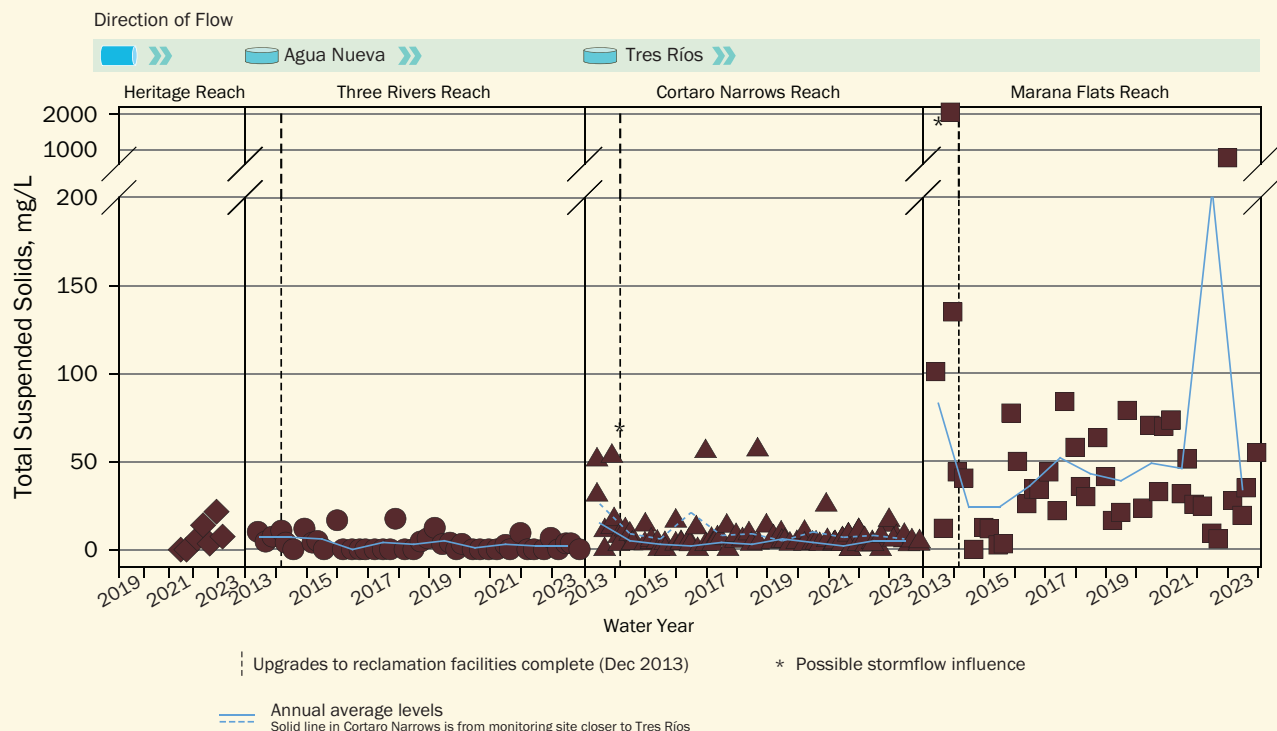
Levels of total suspended solids naturally increase during flooding conditions with extra stormwater. The Arizona Department of Environmental Quality (ADEQ) does not have a standard for total suspended solids. The concentration of total suspended solids in each reach from the 2013 water year serves as a baseline.

### 2013–2023 RESULTS

Total suspended solids (TSS) were measured a total of 179 times during normal flow conditions. Levels of TSS are lowest and least variable in the Heritage and Three Rivers reaches. Cortaro Narrows had decreased levels of TSS since 2013, with only occasional high levels observed. Marana Flats had the most variable levels of TSS. From 2014–2015, TSS briefly decreased in Marana Flats after the upgrades were complete. After 2015, TSS levels in Marana Flats increased though remained lower than levels recorded before the upgrade. Levels appear to be dropping in 2022 and 2023 with the exception of a late 2022 water sample that recorded the highest recent level of TSS for unknown reasons (there was no stormwater influence).

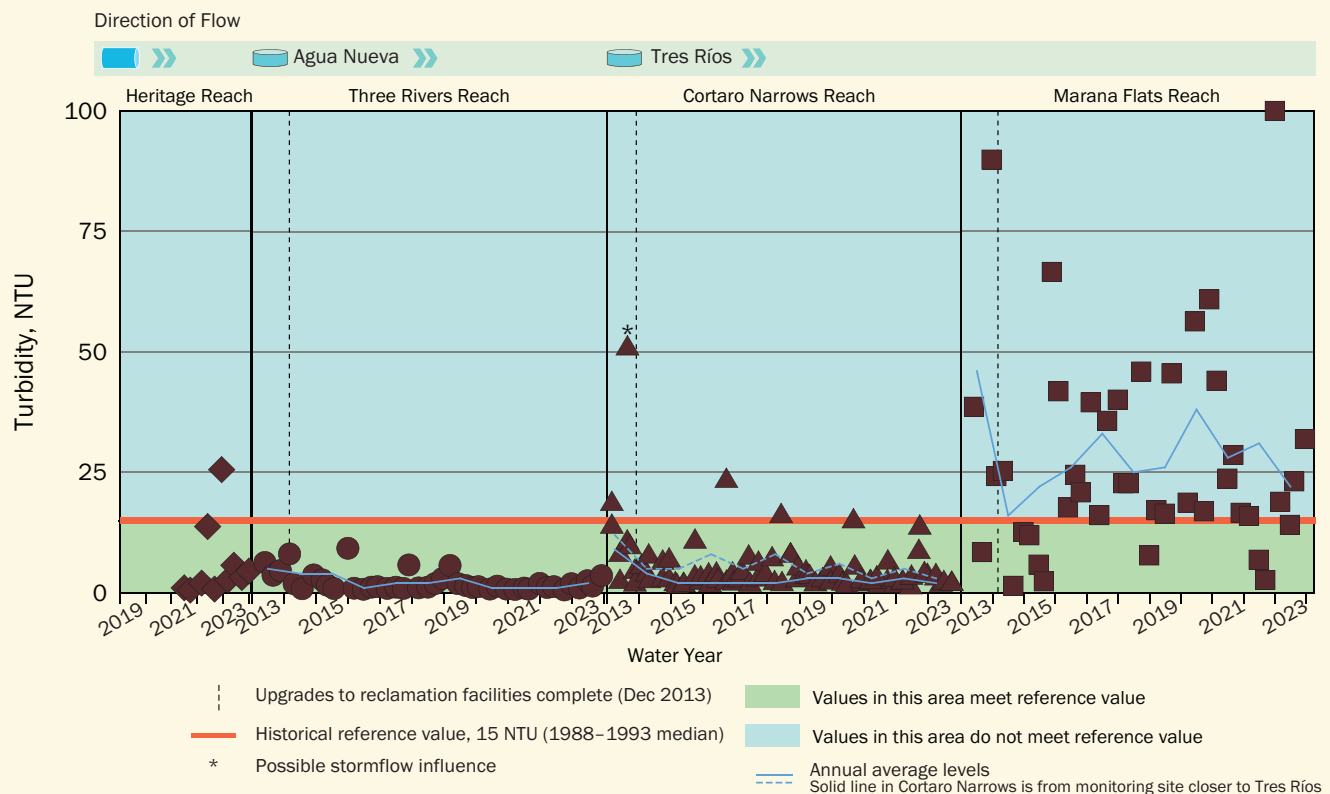
Turbidity Units (NTU). High NTU indicates the water is cloudy and hard to see through. The 1988–1993 median level of turbidity in the Cortaro Narrows reach was 15 NTU. ADEQ does not have a standard for turbidity, so this assessment uses 15 NTU as a historical reference value. This is slightly higher than a typical value of 10 NTU for a river with normal base flow and no stormwater influence.

## 2013–2023 RESULTS

Turbidity was measured throughout the year at several locations for a total of 179 times. Overall, the reference value was met 142 times (79%). Average turbidity within Three Rivers and Cortaro Narrows has decreased since the 2013 upgrades were complete; both have averages below 10 NTU. Although average turbidity decreased in Marana Flats following the upgrades, values have been higher and most variable in this reach since 2016, with the highest reading in 2022.

Measures of turbidity in the Heritage Reach began in the 2021 water year and were far below the two reference values. In 2022 a high value caused an increase in the average of this measure to 11 NTU, higher than it was before but still below the 15 NTU historical reference value used for the river.

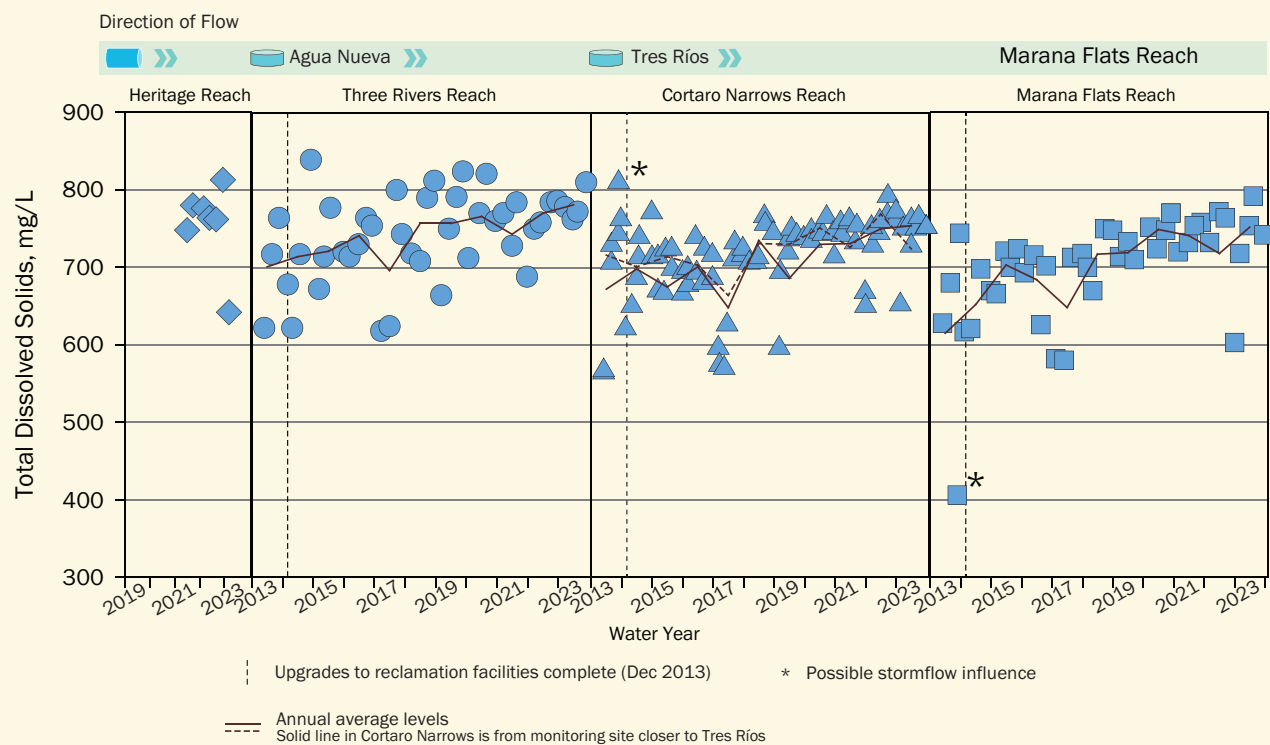
greater TDS, mostly in form of dissolved salts, than the local groundwater. Because there is no standard for TDS (often standards are for individual elements that contribute to TDS), the results from the 2013 water year will serve as a baseline. Freshwater generally has TDS <1,000 mg/L and stormwater generally has low levels of TDS.

### 2013–2023 RESULTS

Total dissolved solids (TDS) were measured 178 times. Overall, levels of TDS were similar in all three reaches downstream of Agua Nueva. Average levels appear to be increasing in all reaches and decreasing with distance from the treatment plant. The reason for this trend is unknown. The lowest measure of TDS was in Marana Flats. This sample was collected on a day where there was possible stormwater influence—the addition of water with lower TDS levels may have diluted the levels in this reach of the Santa Cruz River. Samples of stormwater are collected upstream of Agua Nueva when possible. Four samples collected (one each year during the summer monsoon in 2013–2016) averaged 280 mg/L.

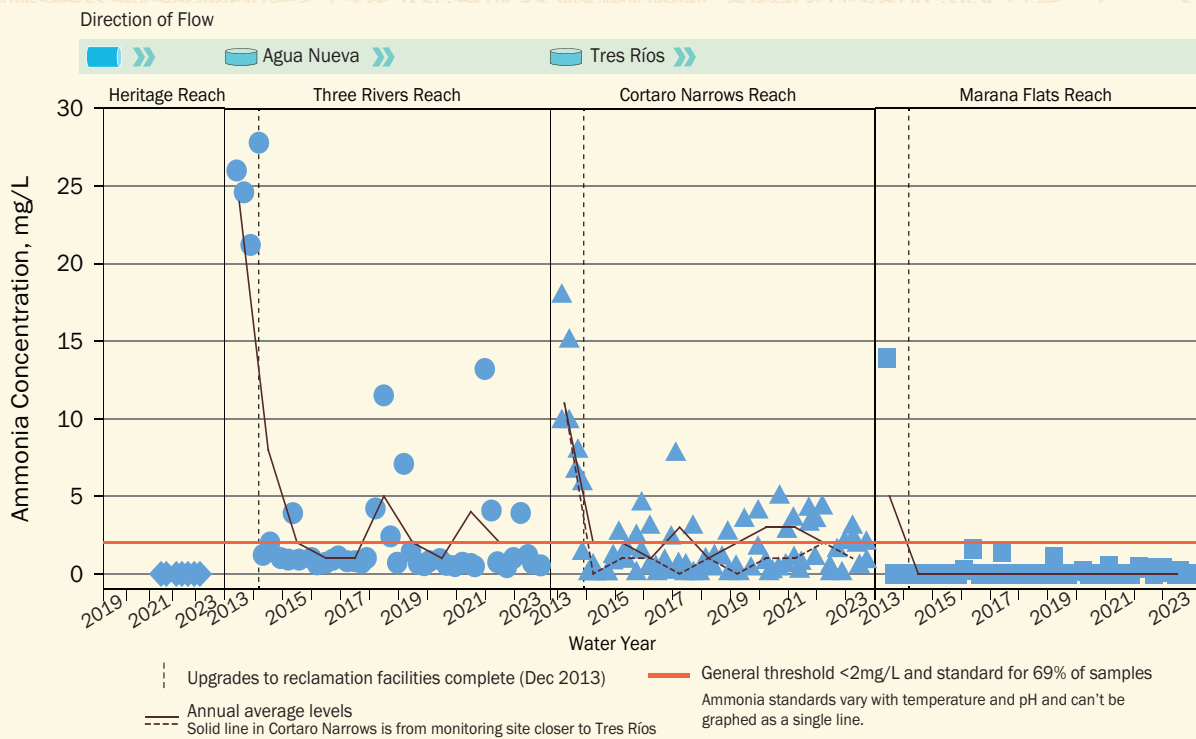
low concentrations, ammonia can reduce hatching success for fish and amphibian eggs, among other impacts. The ADEQ standard for ammonia varies with pH (level of acidity) and temperature. As pH and temperature increase, the toxicity of ammonia increases; thus, the acceptable level of ammonia decreases with high pH and temperature. A general threshold often used is  $<2 \text{ mg/L}$  to avoid toxic conditions.

### 2013–2023 RESULTS

Ammonia was measured 177 times along the river and met the standard 130 times (73%). The standard varies with pH and temperature but was  $<2 \text{ mg/L}$  for 68% of the samples. Levels of ammonia have dropped significantly after the upgrade was complete in 2013. Levels of ammonia also decreased with distance from the reclamation facilities, as it converts into other forms of nitrogen while moving downstream. Measured at four locations (two locations in Cortaro Narrows reach), average ammonia concentrations declined from a toxic  $13 \text{ mg/L}$  in 2013 to  $1 \text{ mg/L}$  in 2014–2023.

Occasional elevated levels of ammonia are observed near the Agua Nueva and Tres Ríos Water Reclamation Facilities. Removing ammonia is a complex process. The facilities use a five-stage process that features alternating oxygenated and oxygen-free zones. To prevent any occasional spikes in ammonia, Pima County regularly optimizes processes to better maintain the delicate balance of oxygen needed for maximum ammonia removal. A spring 2021 addition at Tres Ríos is a Nutrient Recovery System, NuReSys, installed to help reduce buildup of magnesium ammonium phosphaste (struvite) in pipes and phosphorus return loading. This system sequesters struvite from the wastewater in a biosolid product and has likely contributed to lower average ammonia levels at the site closest to Tres Ríos (2021 average:  $3 \text{ mg/L}$ ; 2022 and 2023 averages:  $2 \text{ mg/L}$ ).

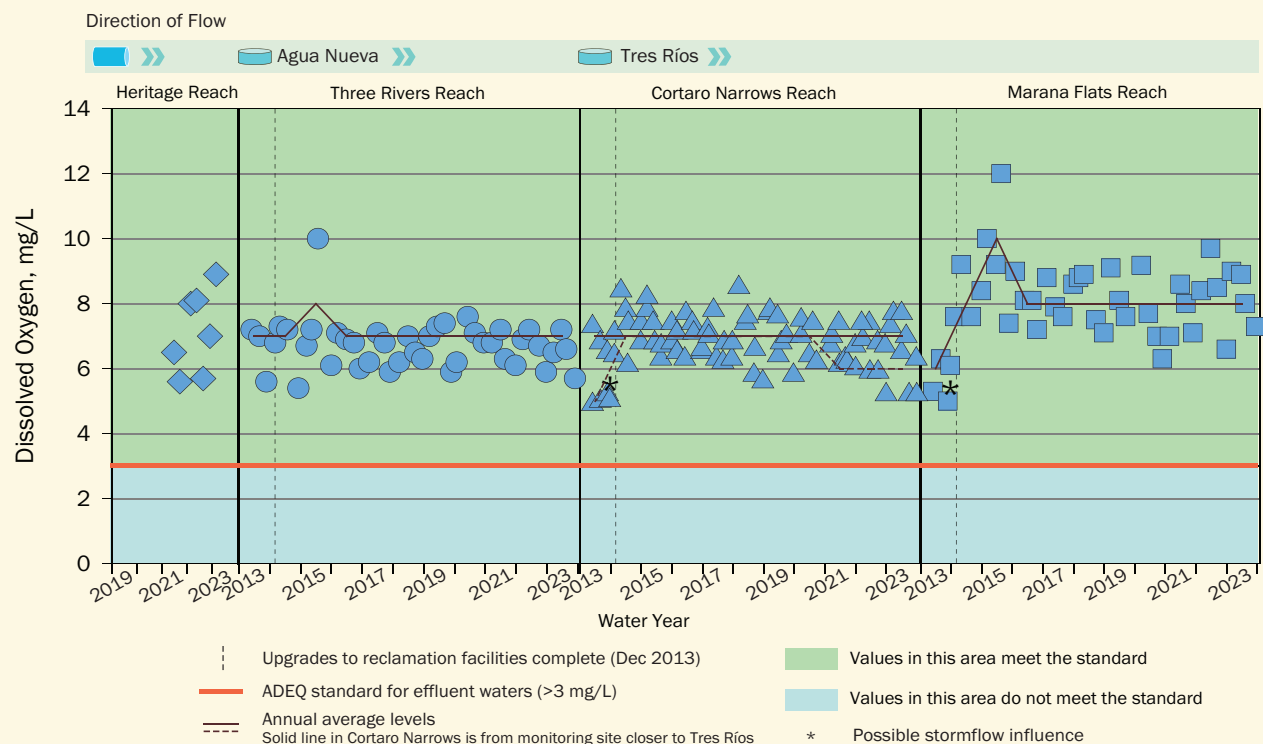
temperature, decay of organic materials, and time of day. ADEQ sets the minimum standard for dissolved oxygen in streams dominated by effluent at 3 milligrams per liter (mg/L) during the day (3 hrs after sunrise to sunset).

### 2013–2023 RESULTS

Dissolved oxygen was measured 177 times along the river. All of the samples met the standard for dissolved oxygen (100%). Levels of dissolved oxygen stayed fairly constant in Three Rivers and Cortaro Narrows. However, starting in 2014 Marana Flats saw an increase in dissolved oxygen. The reason for the increase only in this reach is unknown.

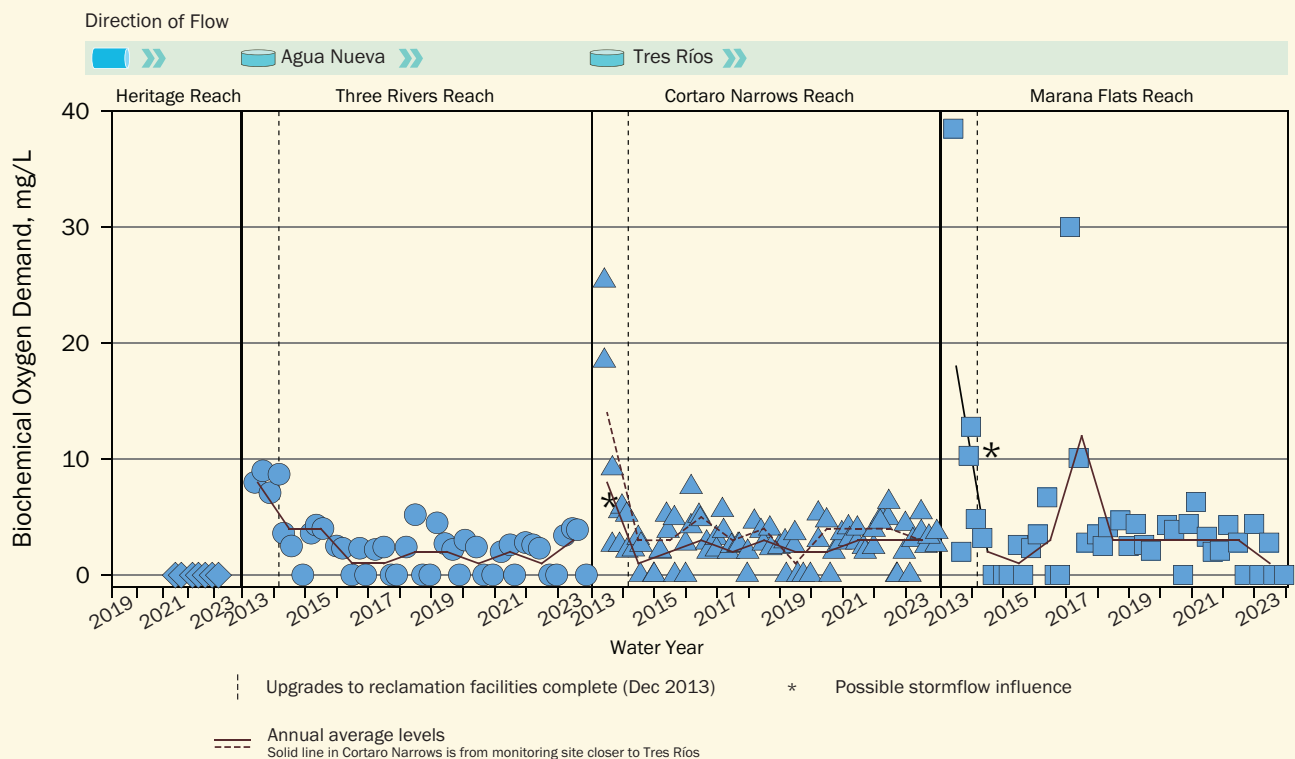
oxygen and deprive other aquatic animals of the oxygen they need to survive. Though there are standards for BOD in the wastewater reclamation process, which are met in the released effluent, there is no standard for BOD in rivers. The 11 mg/L average from the river during the 2013 water year serves as a baseline value to track changes.

### 2013–2023 RESULTS

Biochemical oxygen demand was measured 179 times along the river. BOD has decreased since the upgrades to the reclamation facilities were completed. The high levels observed in Cortaro Narrows are absent after the 2013 water year. This pattern is generally the same in Marana Flats except that, for reasons unknown, measures of BOD in the first half of 2017 were similar to the high levels observed during the 2013 baseline.

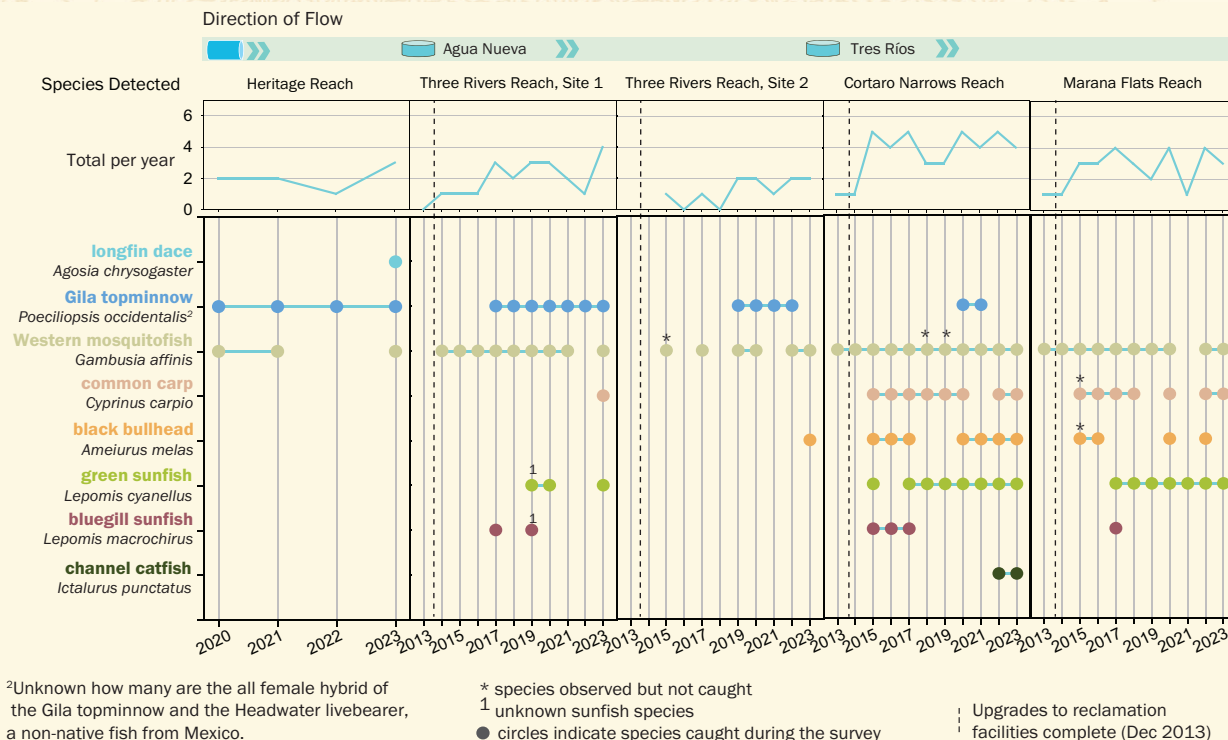
that went extinct when the river ceased to flow year-round. There is no standard for abundance or diversity of fish. The results from the 2013 water year will serve as a baseline for measuring change in subsequent years.

## 2013–2023 RESULTS

Fish surveys were conducted annually in the fall at four locations with two sites located in the Three Rivers Reach. Surveys aim to detect all fish species present at a location, but do not try to assess population numbers. Improvements in water quality have allowed fish to thrive. Overall, the number of fish species observed increased from one to eight. All are non-native, except for the endangered Gila topminnow and longfin dace. Recording the most species, the Cortaro Narrows reach may provide the most diverse habitat for fish. Flows in the Three Rivers reach are often very shallow and may favor smaller fish like the Western mosquitofish and Gila topminnow, although occasional sunfish have been seen and in 2023 small common carp were found at site 1. Though Gila topminnow continue to be found in the Three Rivers reach, the catch-per-unit effort (a measure of how easy it is to find a species) decreased in 2023. Another challenge is that we don't know the number of topminnow that are the all female hybrid with the closely related species from Mexico. An analysis of this kind would require examination of genetics or teeth (see next page for more information about this hybrid.).

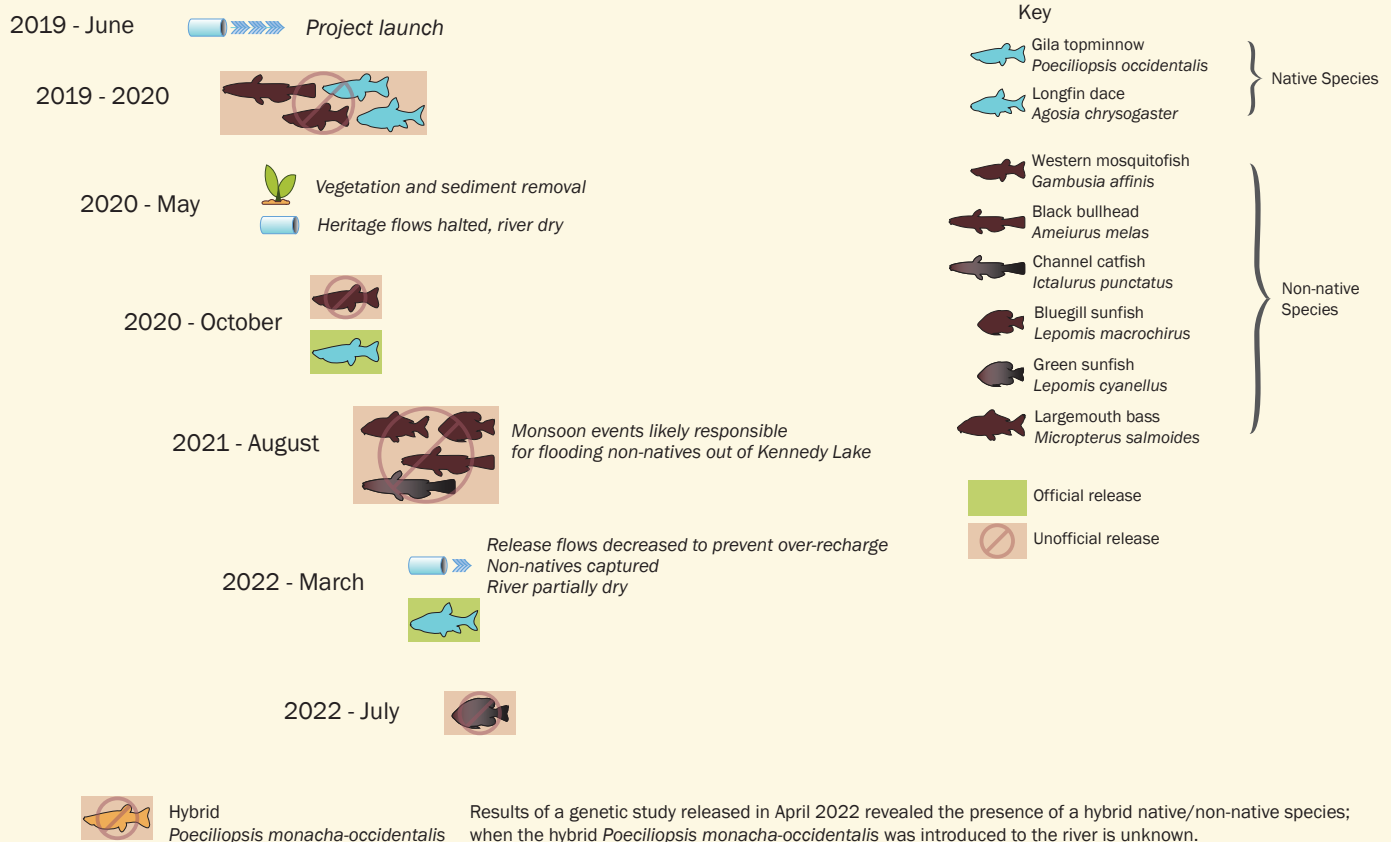
### Timeline of Heritage Reach Introductions

Illegal introductions have been observed in the Heritage Reach from the beginning of the project. After its launch in 2019 multiple species were discovered in pools that subsequently dried, resulting in the death of those populations. Similar fates were met by fish released just before Pima County conducted a sediment removal project. Sometimes weather events can cause flooding that flushes non-native species into the river from nearby sources such as Kennedy Lake, which is stocked with sport species for recreational fishing. However, often these introductions are suspected to have been the result of illegal human action. Western mosquitofish that were discovered in the Heritage Reach in 2020, just prior to the planned release of Gila topminnow, are now an established non-native species that poses an ongoing threat to the native's success, and in July 2022, green sunfish were discovered near the outfall of the Heritage Project without any prior flooding.

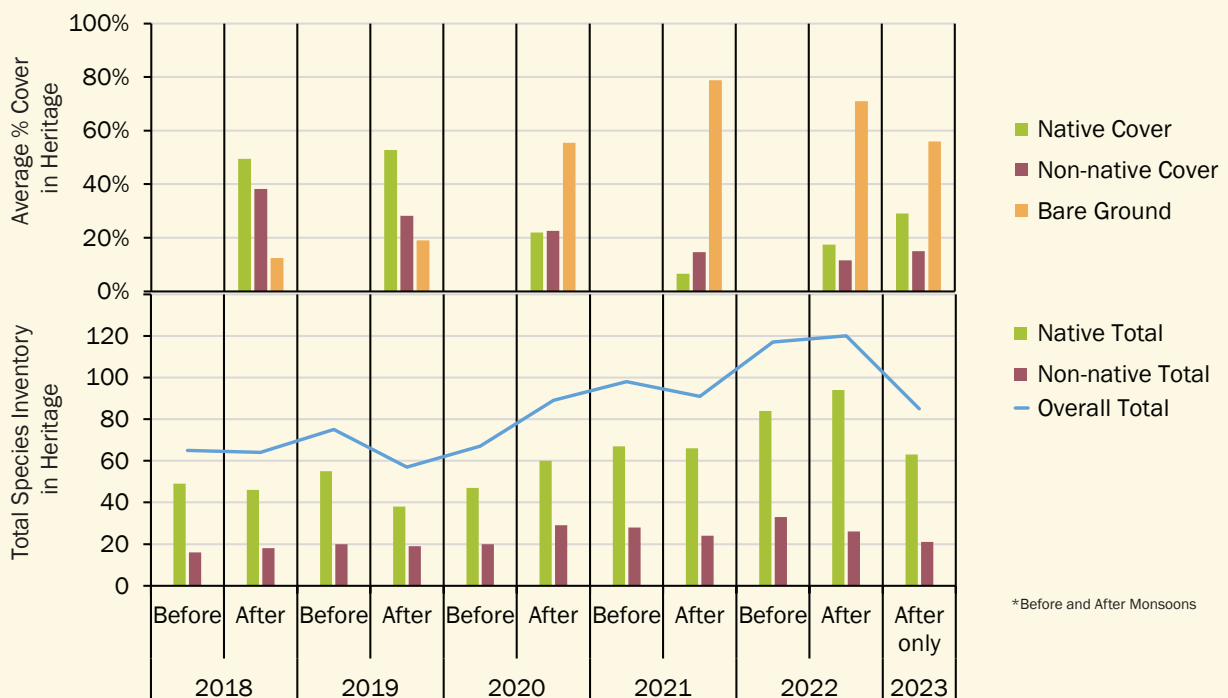
District in 2020 to improve conveyance of floods through downtown. Surveys before the monsoon monitor changes in vegetation in response to human and natural conditions: water release, flood control, re-seeding and planting, weather and general ecological change. Surveys after the monsoon aim to identify monsoon influence on vegetation and monitor species planted or seeded. Organized seed dispersal intends to help restore the riparian vegetation and re-establish native species. The initial surveys from 2018 and 2019 help establish a baseline for ongoing monitoring, but more data is available from the 2020 survey.

### 2018–2023 RESULTS

Overall, number of native species has increased even as percent cover has been variable. In 2023, there was no “before” data collected prior to the monsoon. In comparing 2023 data to the before and after 2022 monsoon season, the total number of native species decreased, as did number of non-native species. However, the percent of native cover was the highest it’s been since 2020. Cover by non-native species remained similar to surveys in 2022 and 2023. This is good news for native vegetation persisting even with variable flow conditions and reduced water released from the Heritage outfall.

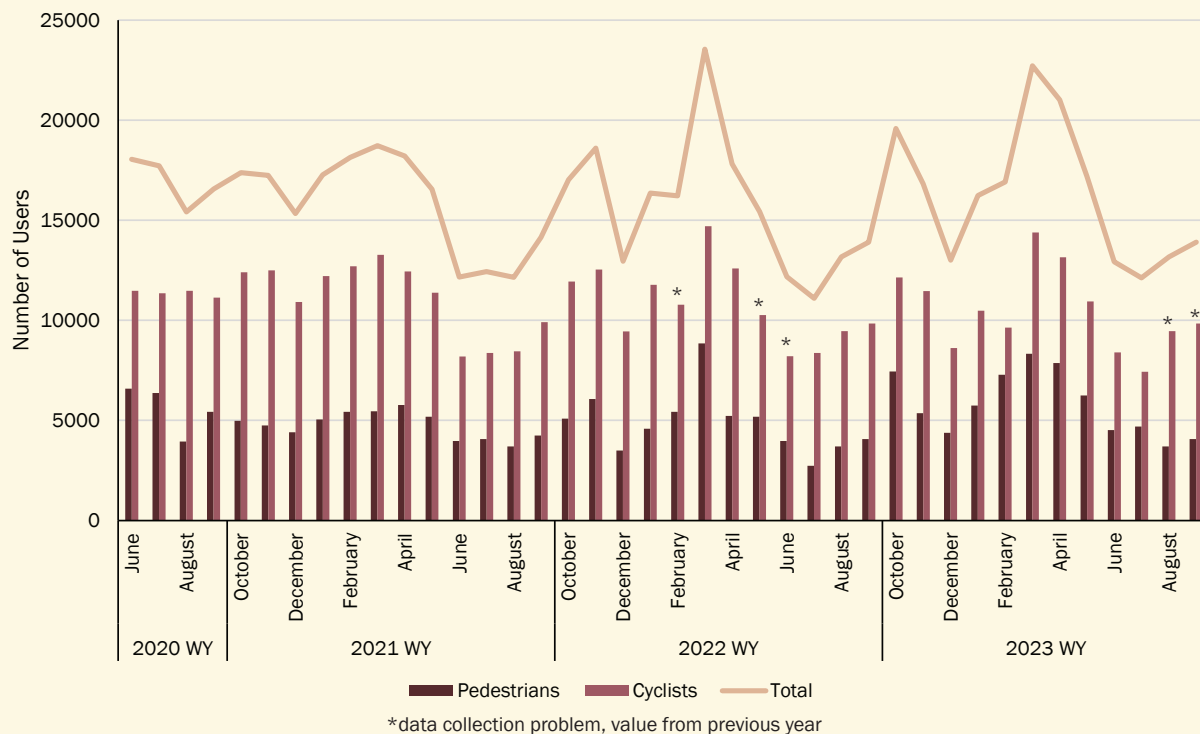
Parks. Users in the Santa Cruz River Park can now connect with the Rillito and Pantano Parks, Harrison Greenway, and Julian Wash on a 53.9-mile circuit. Over the past two years, Pima County has installed counters to monitor activity along the multi-use path, with one counter along the river between the flowing reaches. These counters differentiate between cyclists and pedestrians, allowing trends of use to be studied.

### 2020–2023 RESULTS

In the Santa Cruz River Park, from Speedway to Saint Mary’s Road, counter data shows a steady use year-round. Seasonal variation is expected, with the lowest numbers generally occurring in the heat of the summer. On average there are 16,000 total Loop users that get counted on this stretch of the path every month (10,800 cyclists and 5,200 pedestrians). Counters don’t identify unique individuals. If we assume everyone is doing an “out and back” and thus counted twice, we have an average of 250+ people per day traveling along the river in this location. This is a conservative estimate since many cyclists are doing large distances and loops that don’t pass by the same location twice.

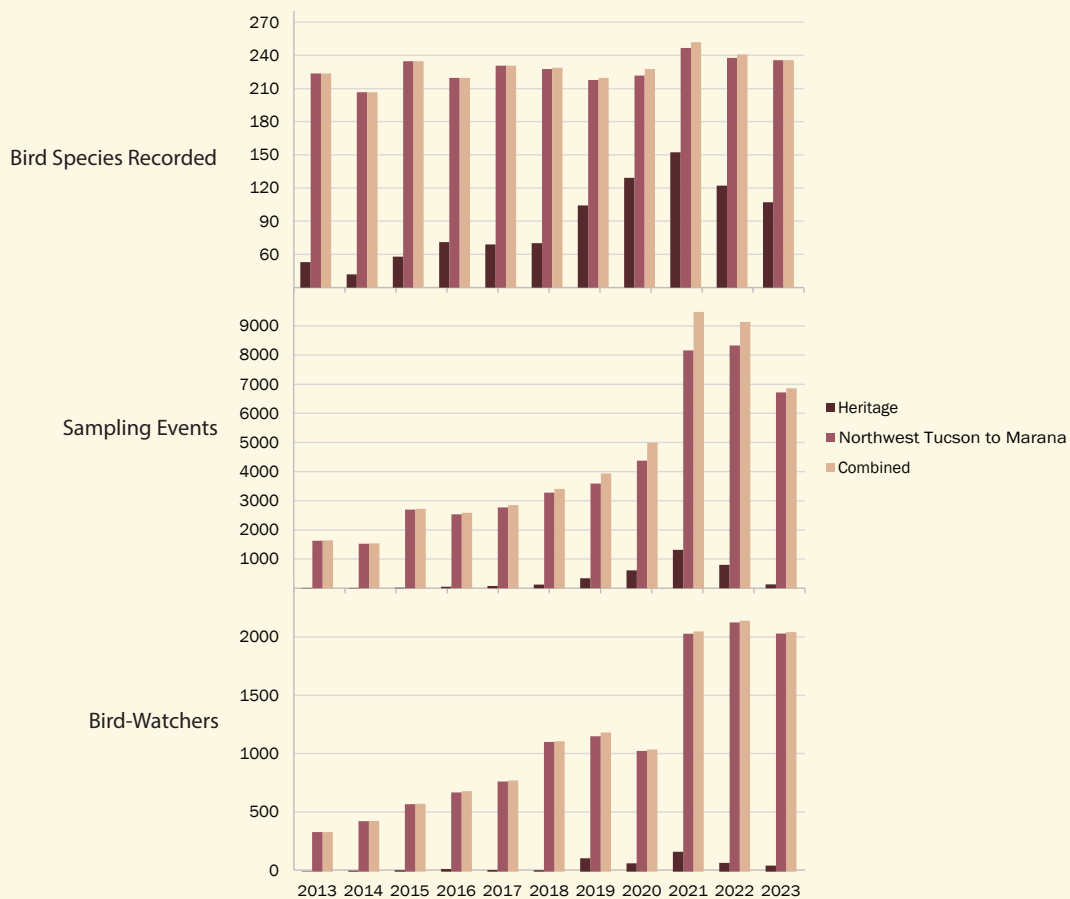
passersby an opportunity to take part in data collection by recording bird species they see along the river, thus providing river managers with an ongoing source of information. For this analysis, we include only observations collected during traveling or stationary counts of species making use of the river corridor and adjacent parks. Birds simply flying over, and those that are exotic or domestic, are excluded to focus on the effectiveness of the area as wildlife habitat.

### 2020–2023 RESULTS

Observed diversity was highest in 2021, which is also the peak year for total number of sampling events in both reaches. Diversity is highest and fairly stable in the northwest Tucson to Marana. However, the Heritage reach has high diversity considering that it is a small reach (~3.4 miles) compared to 23 miles along the northwest Tucson to Marana reach that also includes habitat options such as Sweetwater Wetlands and El Rio Preserve. The majority of bird-watchers recording observations are in the Northwest Tucson to Marana reach. Efforts like this demonstrate the potential of citizen-science efforts, and the latent willingness of communities to be involved in our natural areas.
